**NISTIR 4868**

# **Interim Report: Preliminary Sitewide Survey of Reinforced Concrete Structural Deterioration at NIST**

August 1992

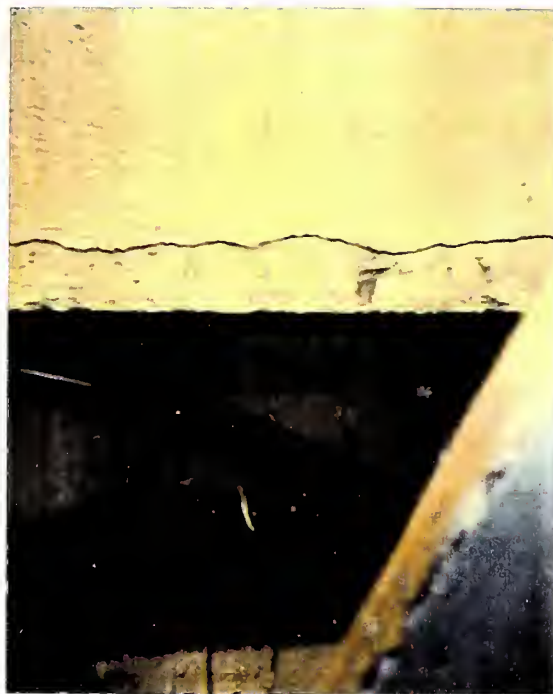
FIGURE 80

TELEPHONE MANHOLE 13: CRACK AT BOTTOM OF ACCESS HOLE

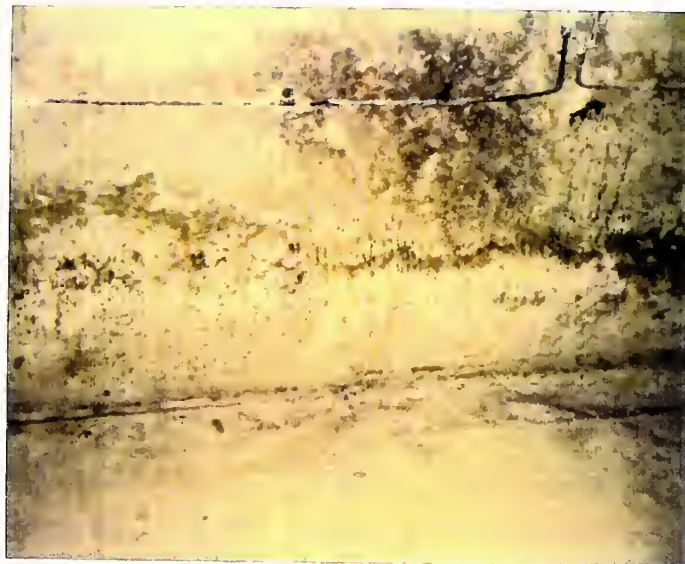
ELECTRIC MANHOLE 13: WEST WALL, SEVERE RUST STAINS

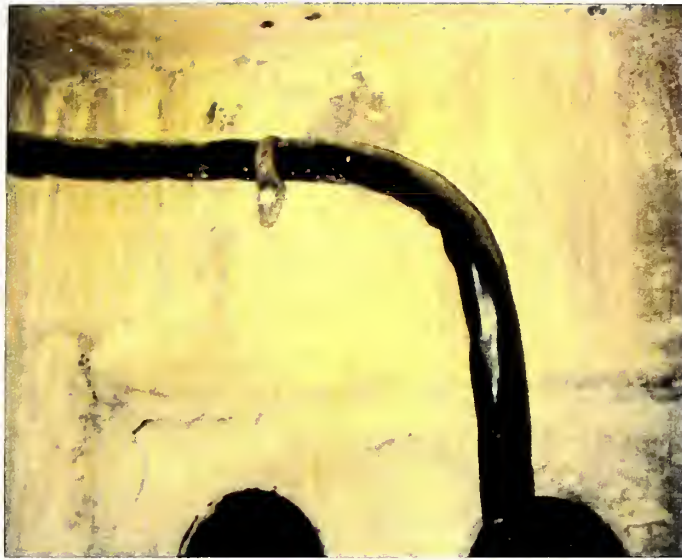
SIGNAL MANHOLE 13: WEST WALL, SEVERE DELAMINATION

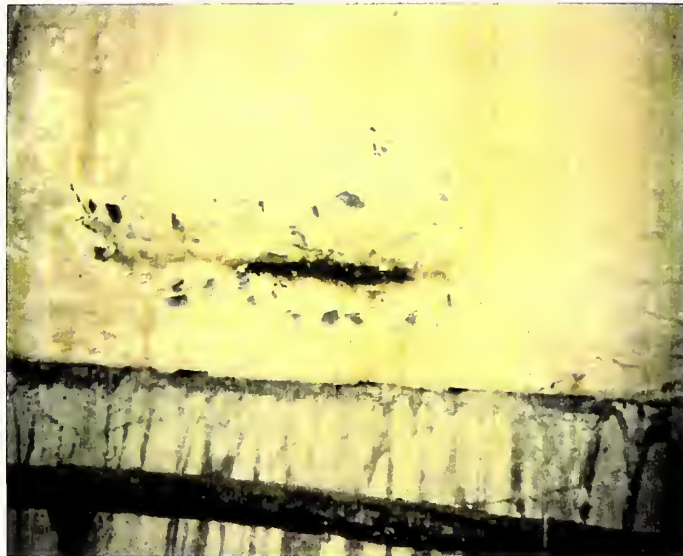
SIGNAL MANHOLE 14: ACCESS HOLE, CRACKING AND EXPOSED CORRODED REINFORCEMENT

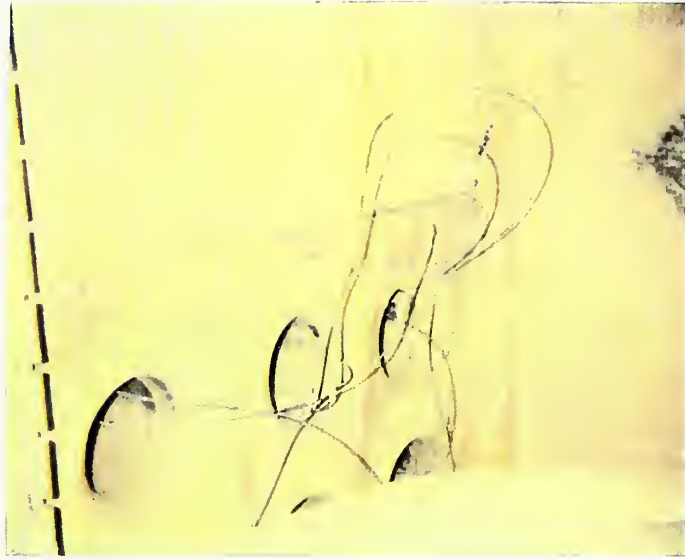
ELECTRIC MANHOLE 21: DELAMINATION AT CORNER

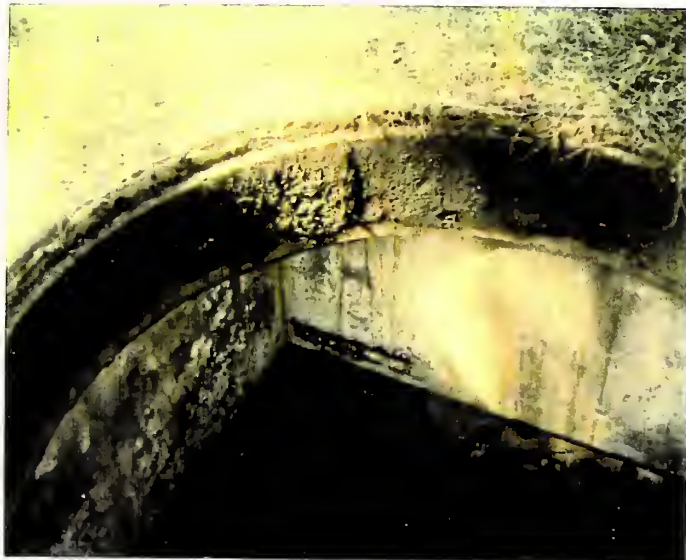
SIGNAL MANHOLE 38: EXPOSED REBAR/DELAMINATION AT ACCESS HOLE

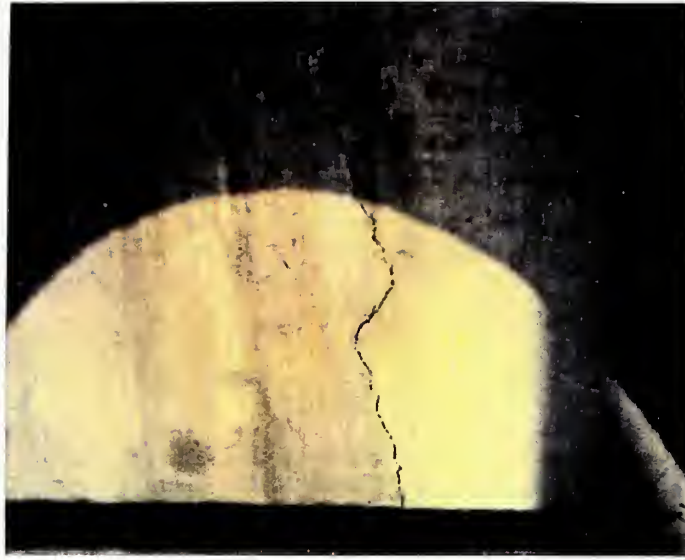
As was shown in Manhole # 67 (Tables 2 and 3), underground structures, such as electric, signal, telephone, and steam manholes which are subjected to vehicular traffic, including trucks, deserve additional attention. It is recommended that at least several structures be investigated which are subjected to truck traffic to determine the severity of the loading due to vehicular traffic. Decisions to repair or replace manholes should take into account loading due to vehicular traffic.

TELEPHONE MANHOLE 67: CRACK IN NORTH WALL (UPPER)

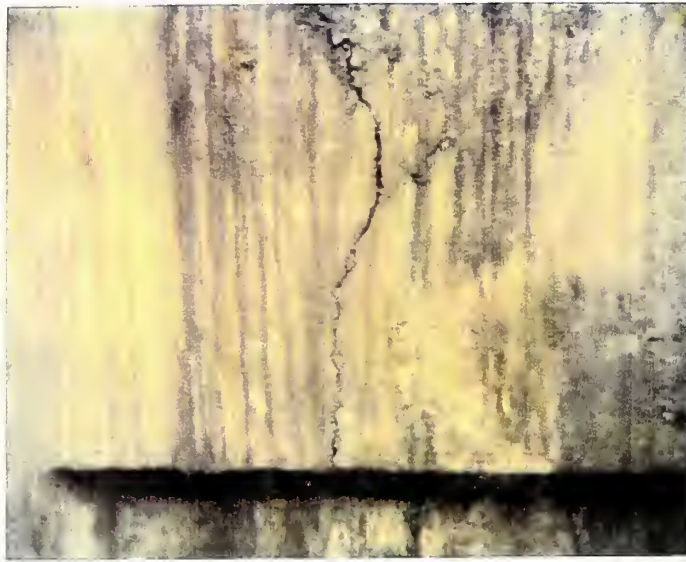
TELEPHONE MANHOLE 67: CRACK IN SOUTH WALL (UPPER)

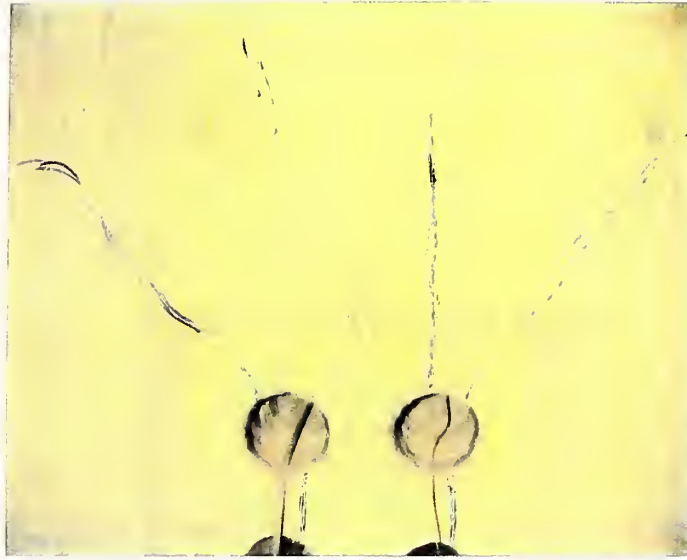
SIGNAL MANHOLE 67: CRACKS IN SOUTH WALL (UPPER) - INK USED ON PHOTO TO ENHANCE CRACKS

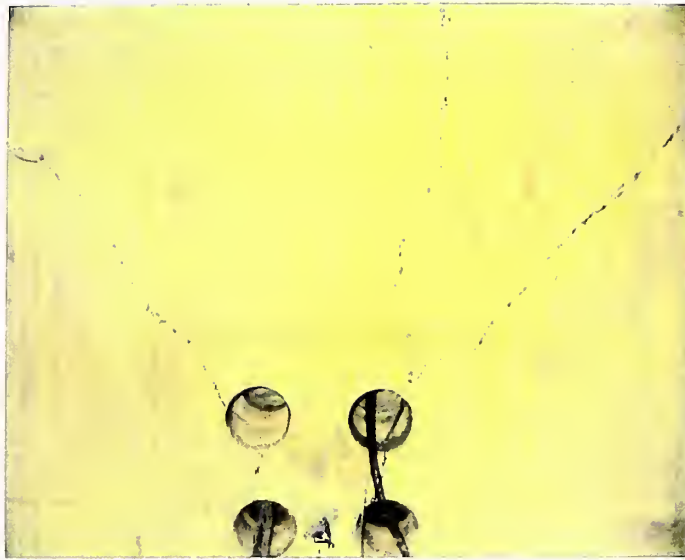
SIGNAL MANHOLE 67: CRACKS IN NORTH WALL (UPPER) - INK USED ON PHOTO TO ENHANCE CRACKS

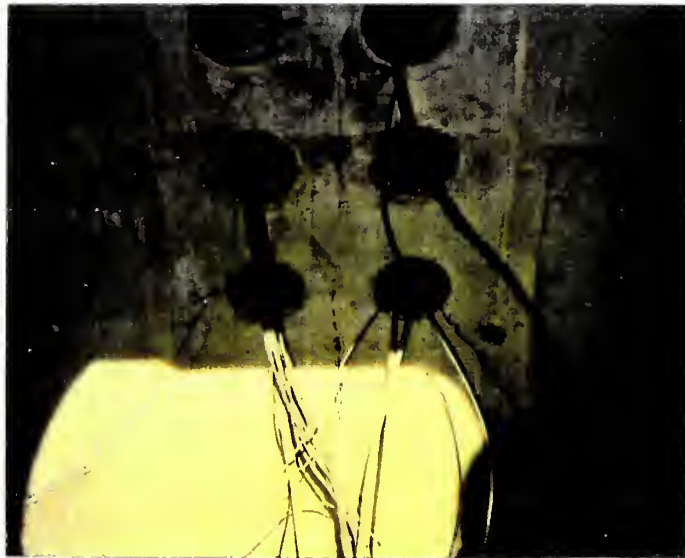
SIGNAL MANHOLE 67: CRACKS IN NORTH WALL (LOWER) - INK USED ON PHOTO TO ENHANCE CRACKS

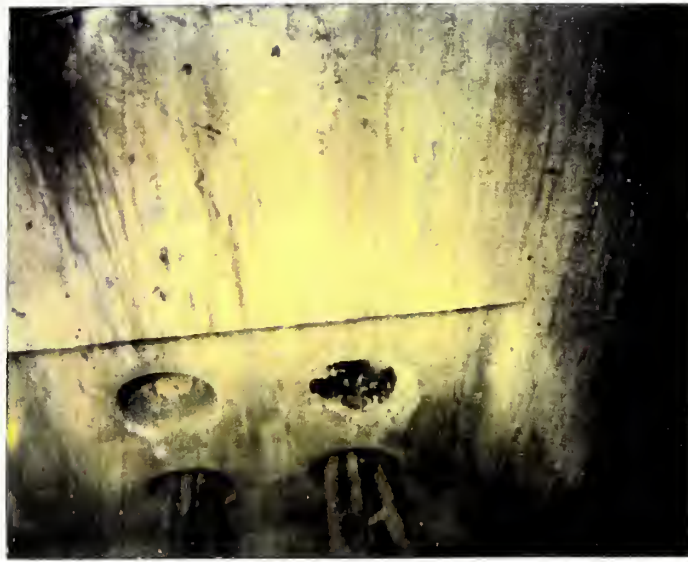
ELECTRIC MANHOLE 67: CRACKING IN NORTH WALL (UPPER)

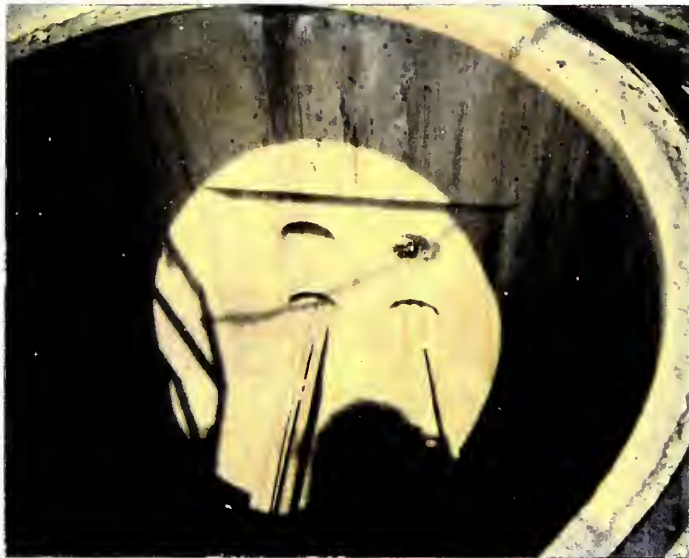
ELECTRIC MANHOLE 67: CRACKING IN NORTH WALL (LOWER)

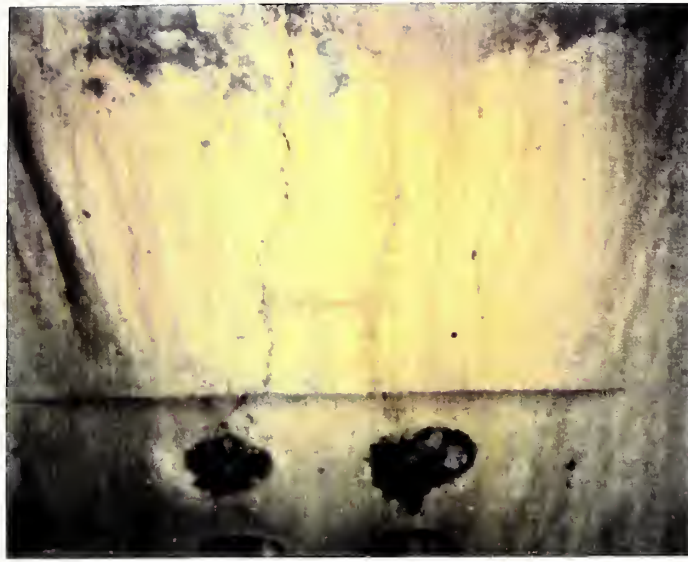
ELECTRIC MANHOLE 67: CRACKING IN SOUTH WALL (UPPER)

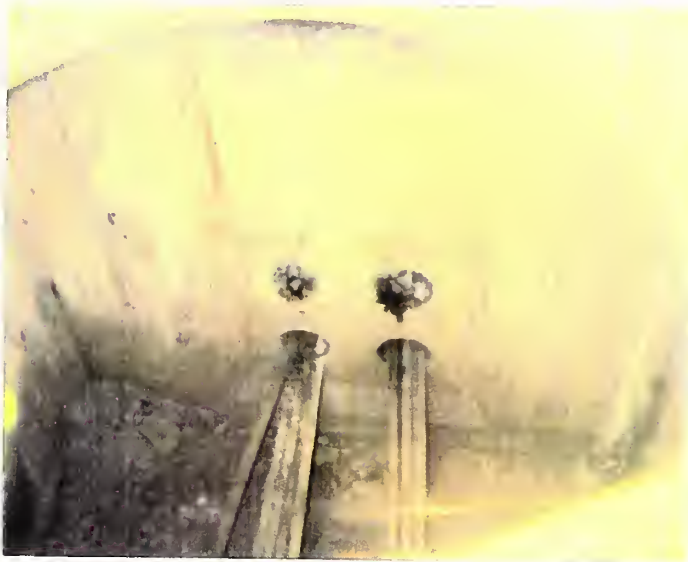
ELECTRIC MANHOLE 67: CRACKING IN SOUTH WALL
